IN THE COURT OF COMMON PLEAS OF ALLEGHENY COUNTY, PENNSYLVANIA

: CIVIL DIVISION
:
: CASE No. _____
:
: Code: 180 – Declaratory Judgment
:
:
: **COMPLAINT FOR**
: **DECLARATORY JUDGMENT AND**
: **TO STAY AND ENJOIN**
: **ARBITRATION**
:
: Filed on behalf of:
: Plaintiff, Silec Cable
:
: Counsel for Plaintiff:
: Gale White (I.D. # 46485)
: Anthony L. Miscioscia (I.D. # 69215)
: Joshua A. Mooney (I.D. # 85945)
: WHITE AND WILLIAMS LLP
:
: 1650 Market Street
: One Liberty Place, Suite 1800
: Philadelphia, PA 19103-7395
: Phone: (215) 864-7000
:
: whiteg@whiteandwilliams.com
: misciosciaa@whiteandwilliams.com
: mooneyj@whiteandwilliams.com
:

On December 18th, 2010, a breakdown occurred in a 220 kV regulation transformer RT12 manufactured and installed by Fuji Electric Corporation, with a feeding 220 kV XLPE cable connected, manufactured and installed by Silec Cable.

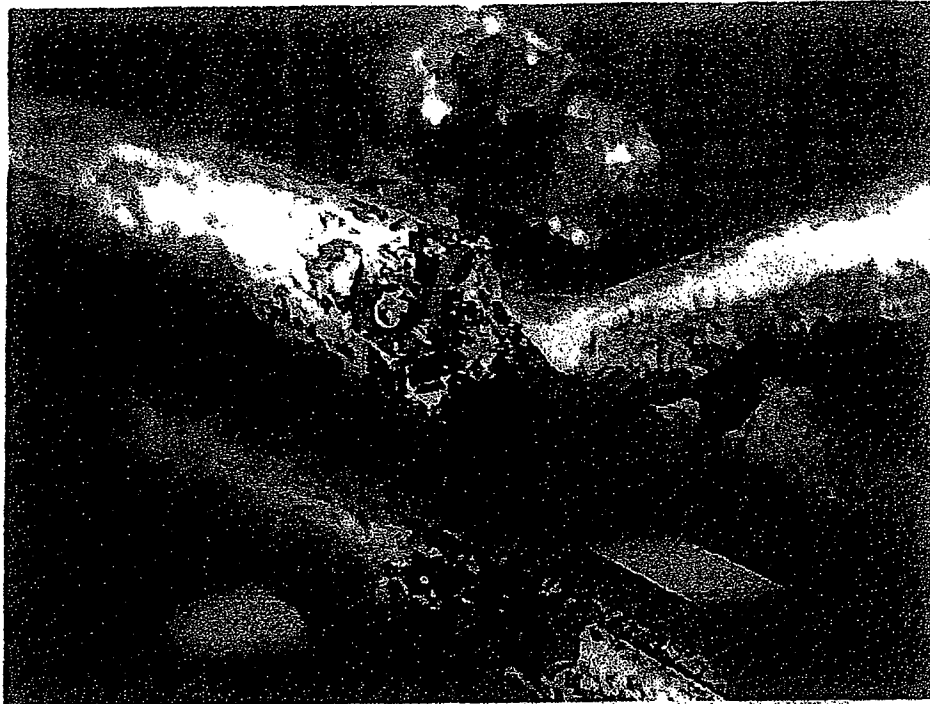
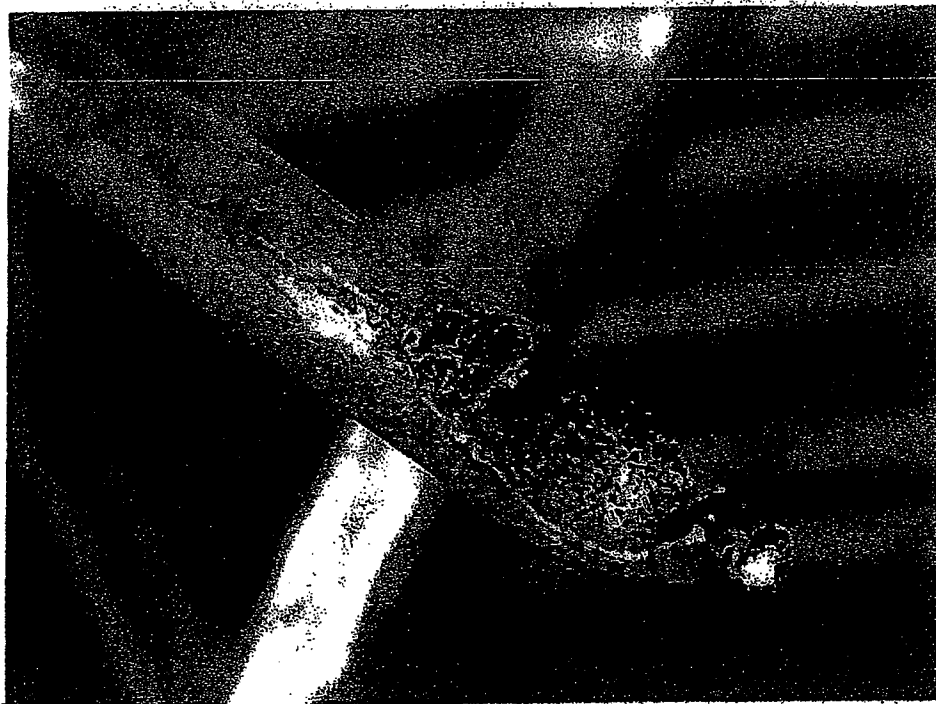
The following photographs are of the arc pattern on W-phase cable, 37 cm below the brass termination cap (Artifact #12A). These photographs were taken with a microscope.

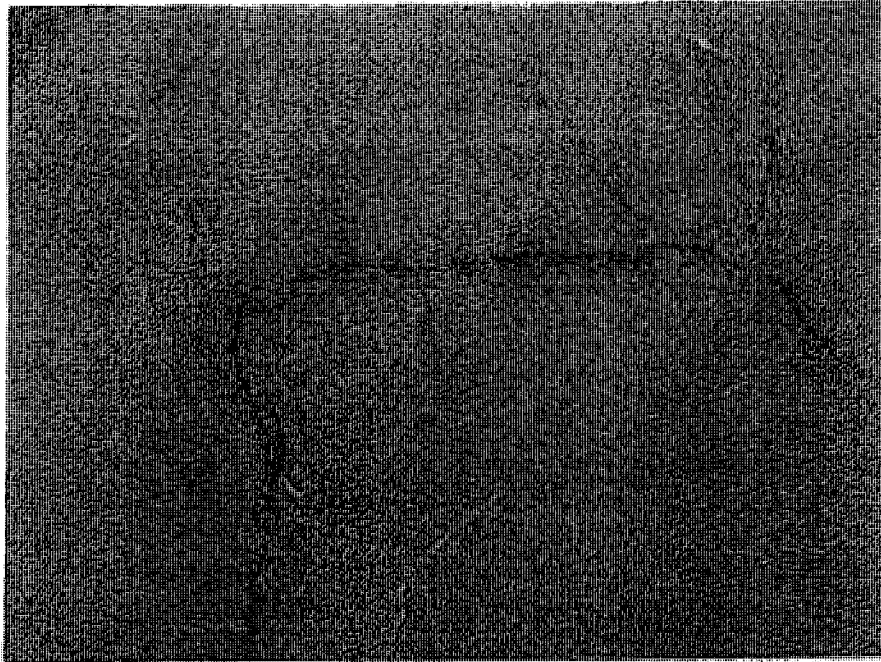
The following 4 photographs are of the insulator piece found in Artifact #23 (#23B). The piece has a curved section to it that indicates it is located at the base of the insulator. All of the partial discharge-caused tracking patterns are located on the internal surface of the insulator. These photographs were taken with a microscope.

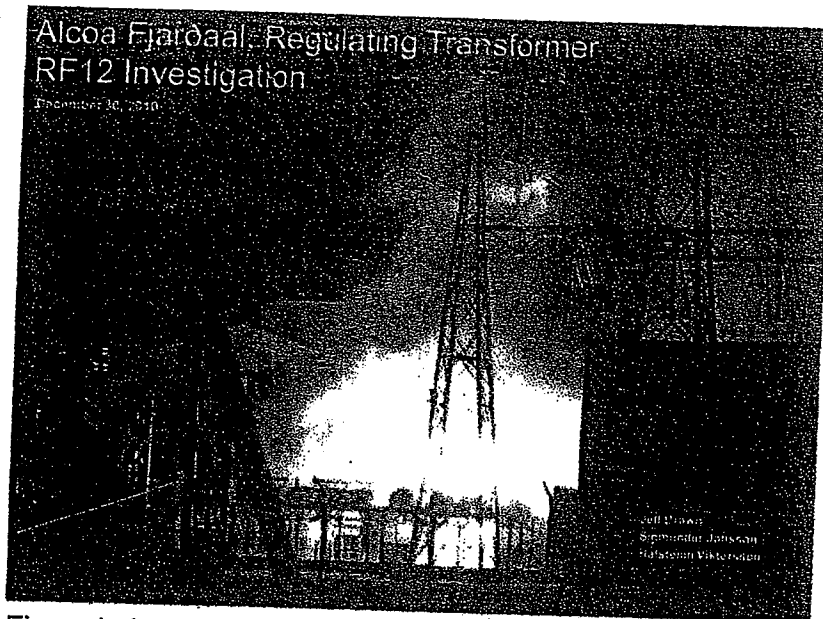
Figure 1 Image of the fire incident after the breakdown in transformer R12 from [14].

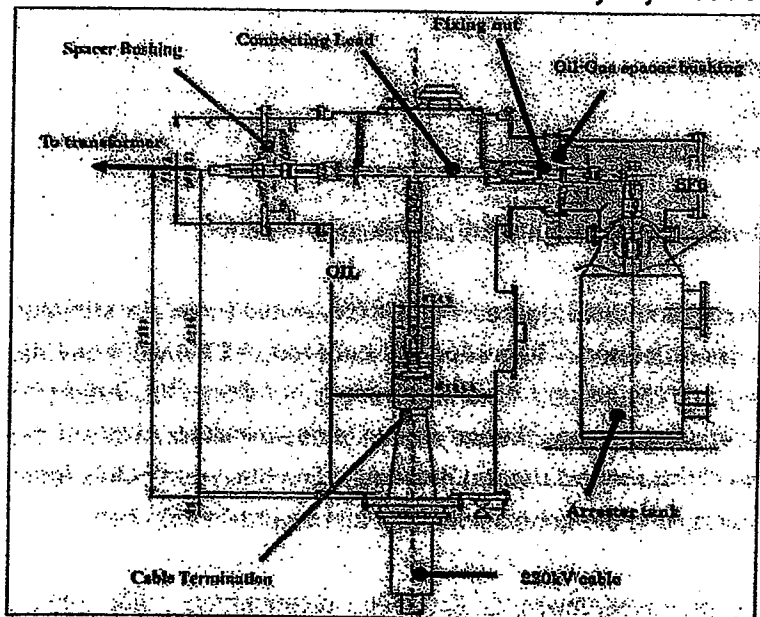
One can see in Figure 2 of the cable junction box that the cable termination is connected to the transformer and to an over voltage arrester via an oil filled compartment and spacers. The arrester tank is filled with SF₆, its pressure being above 1 bar. The transformer and cable junction box are filled with transformer oil at 1 bar pressure. The termination has an insulator of epoxy resin. Not shown in the drawing of Figure 2 is that the connection lead of copper is wrapped with a kind of crêpe paper to avoid bridging of impurities in the oil. The transformer and cable junction box are made and installed by Fuji Electric Corporation.

Figure 2 Internal construction of the 220 kV cable junction box from [14].

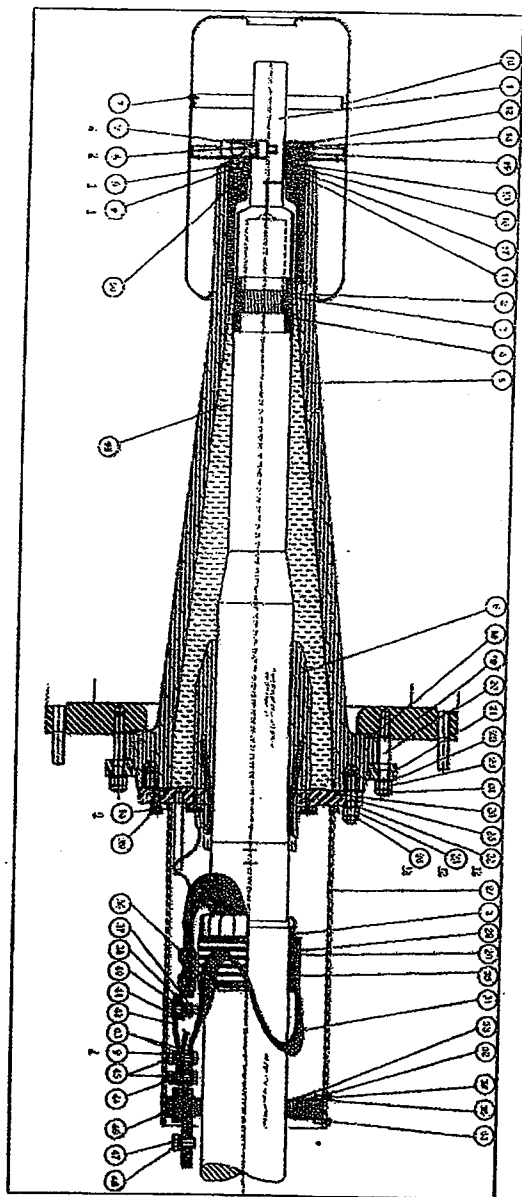
Figure 3 Cable termination construction in the 220 kV cable junction box from [4].

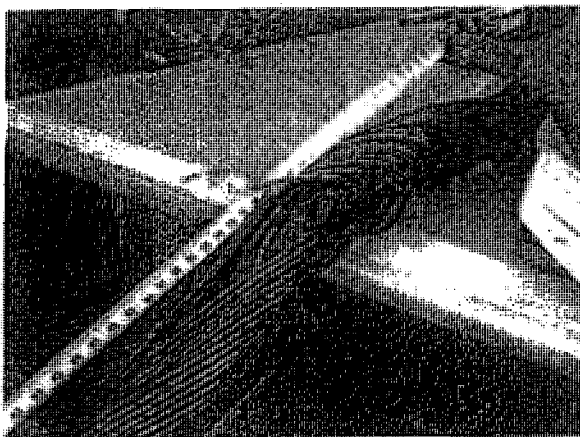
Figure 4 Possible foot point of an arc in the high voltage conductor of the cable, found about 58 cm below the top of the termination.

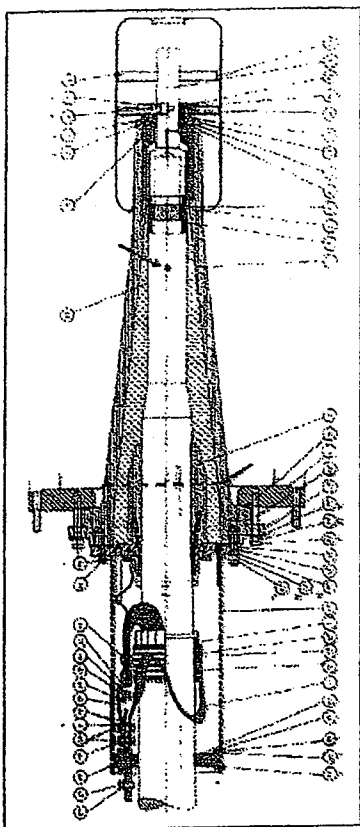
Figure 7 Cable termination with possible foot point of the arc (identified with a red dot and arrow), the possible foot point in the grounded region (blue arrow) and the possible crack area (green line and arrow).

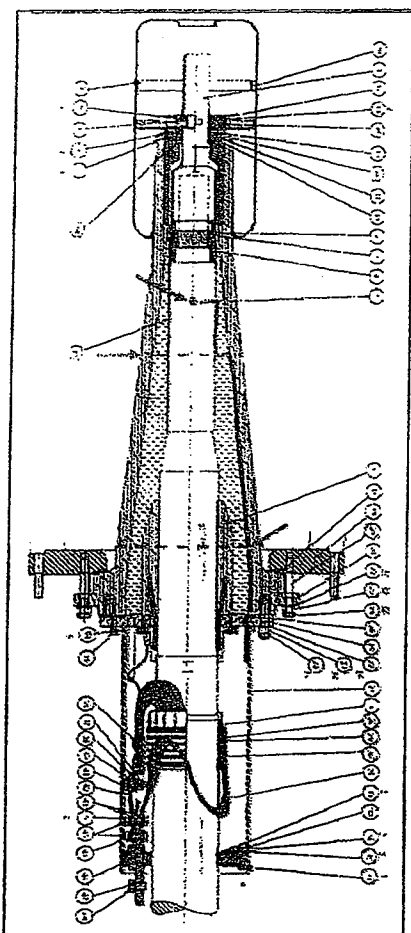
Figure 8 Cable termination with possible foot point of the arc (identified with a red dot and arrow), the oil level just before the breakdown (pink line and arrow), the possible foot point in the grounded region (blue arrow), the possible crack area (green line and arrow) and breakdown arc path (red line).

There are a few things that need a further discussion. It is the acetylene gasses found and its origin and secondly whether the other findings do fit with a breakdown as assumed here. Also of importance is now, what has caused this cracking of the epoxy resin insulator.

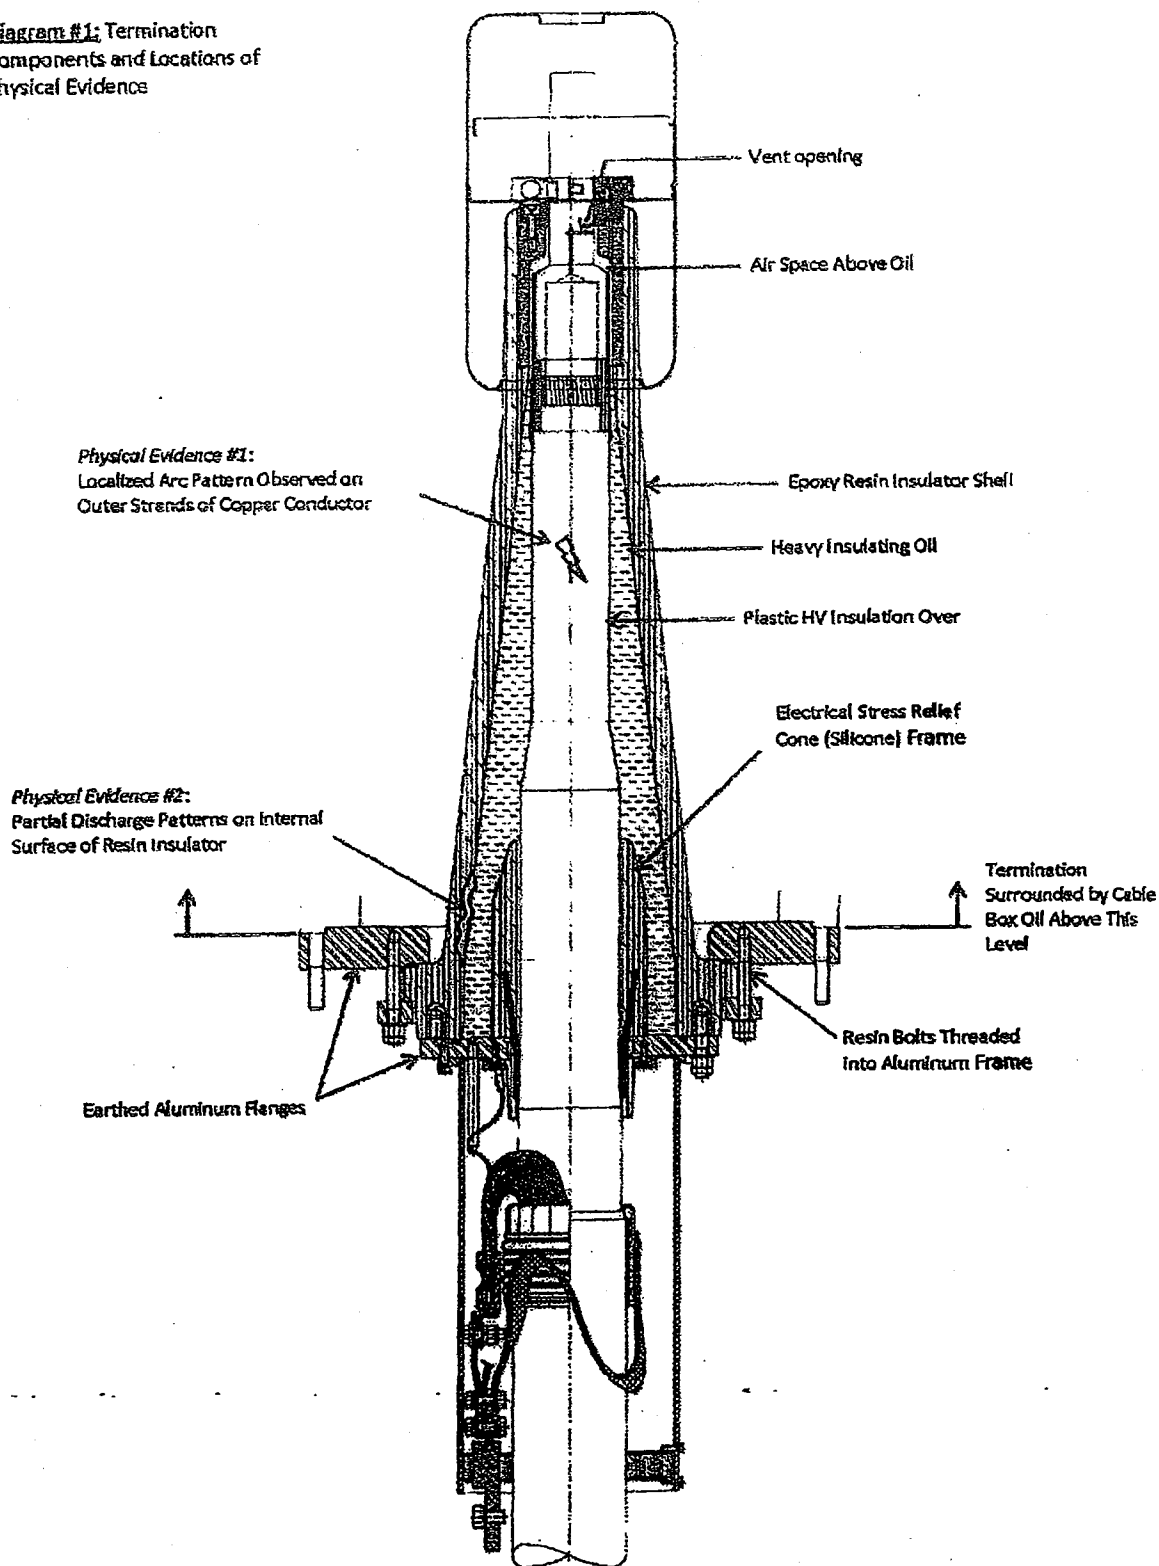
Diagram #1: Termination Components and Locations of Physical Evidence

- A. See Diagrams #1 and #2 on the following pages for a graphic discussion of the termination failure.

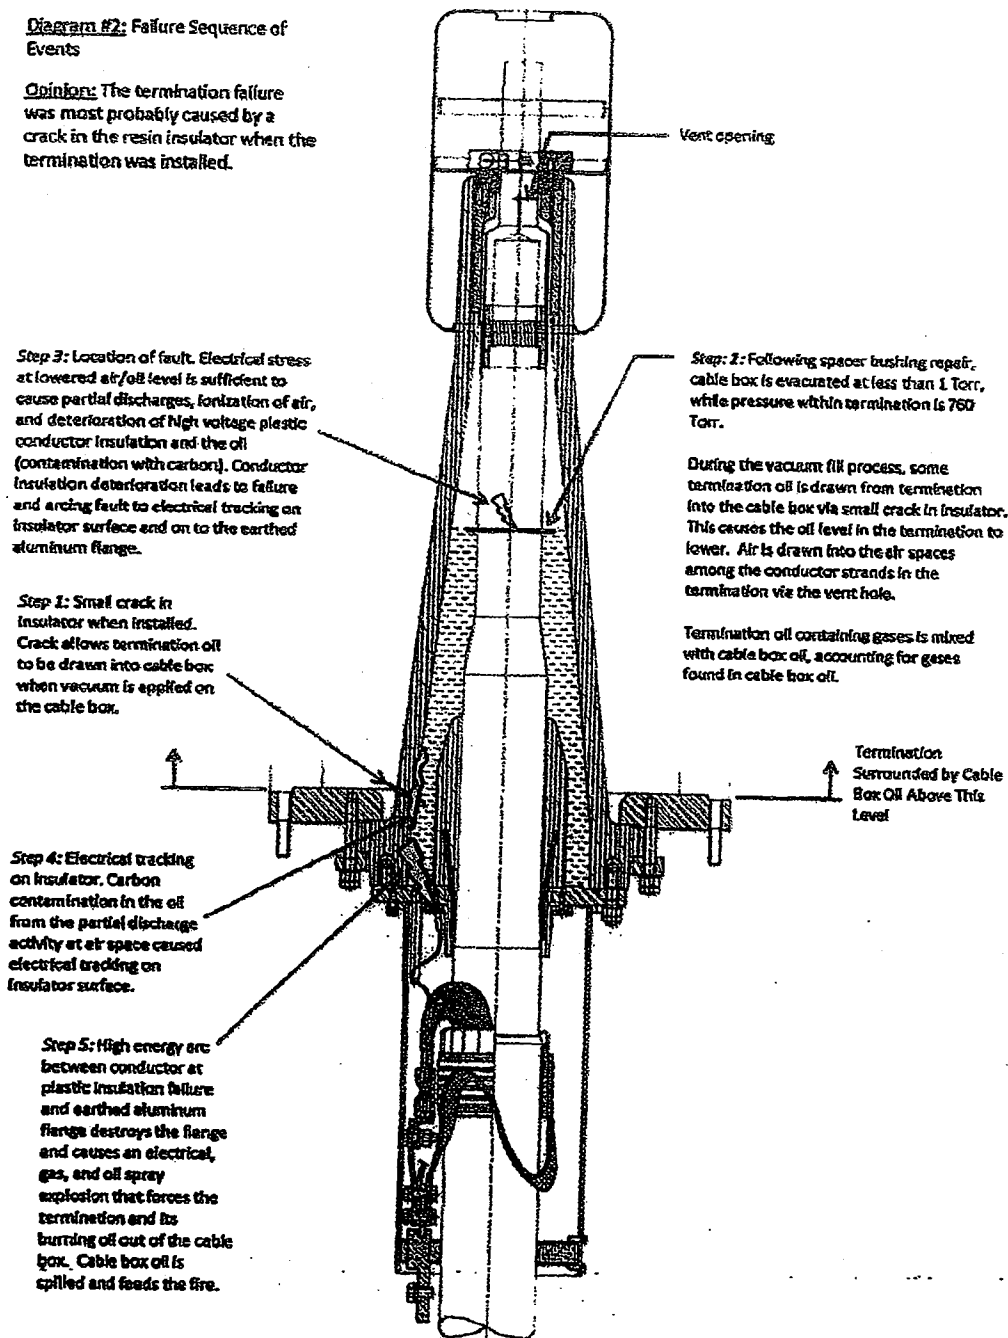
Diagram #2: Failure Sequence of Events

Opinion: The termination failure was most probably caused by a crack in the resin insulator when the termination was installed.

- B. Our general opinion is that the insulator crack allowed some termination oil to be drawn into the cable box when vacuum was applied to it. This occurred twice when the termination was tested and prepared for service in 2007, and once again when the Fuji Electric repair work on the arrester spacer bushing was done in 2009. The crack allowed the oil level in the termination to lower each time vacuum was applied to the cable box. The lowered oil level was followed down by air drawn in from the conductor air spaces via the vent passage. The lower oil level and the presence of air caused partial discharge activity to occur within the termination which
